# Refurbish, repair

The Galaxy Panel Reservoir offered an affordable, safe and efficient water storage solution to the Ntabaskop and Insiminya Community Water Supply Scheme's increasing water loss problems.

# or replace?

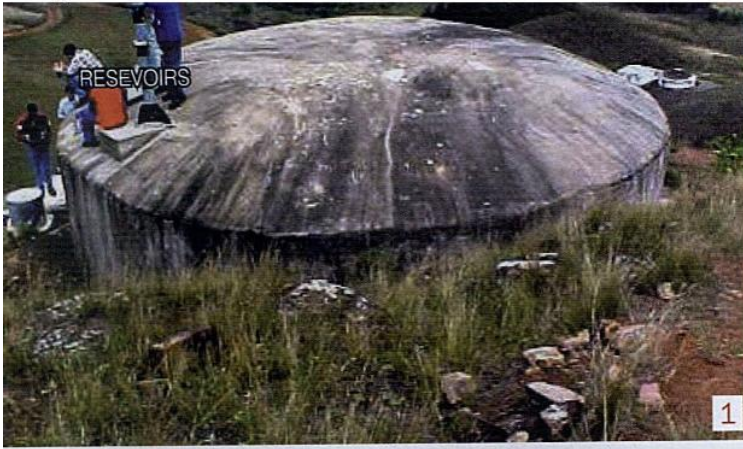
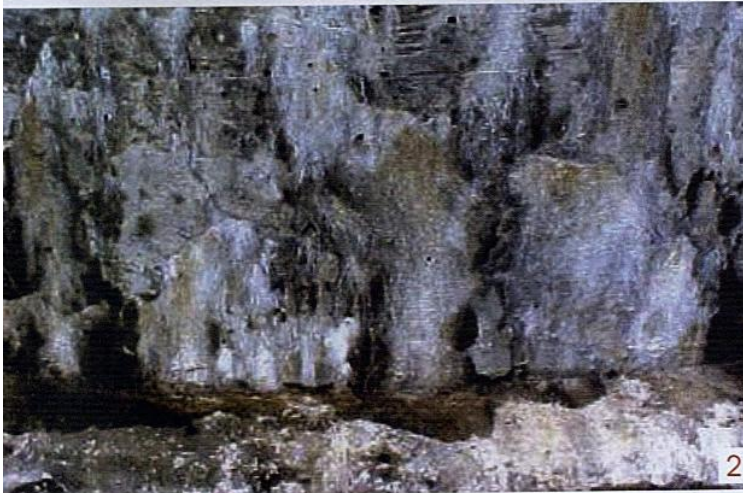
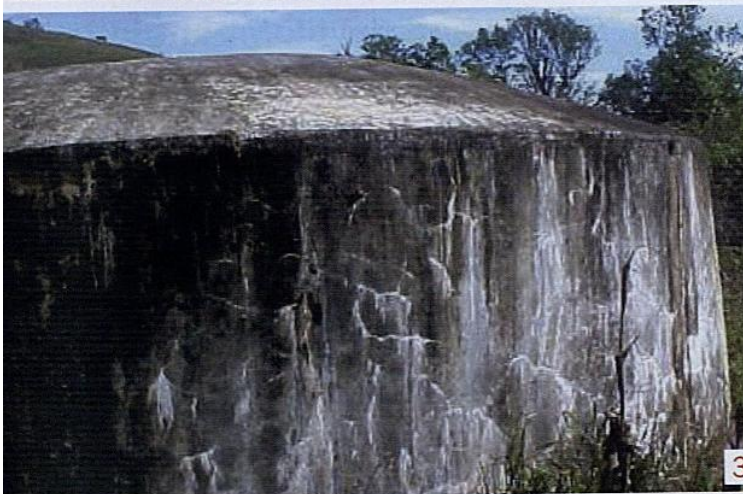
Close investigation of the reservoirs revealed that their failure was largely attributed to substandard and shoddy workmanship, characteristic of many labour-intensive RDP projects of the time. The larger cracks over the entire structure could have been due to weak concrete mixes. The very difficult terrain, hills and poor site access, compounded by very limited access to good clean water and raw materials have indeed contributed to these failures. The urgency to repair these reservoirs was further compounded by a need to transfer ownership of the reservoirs from the local water committees, supported by Umgeni Water to the newly-appointed

1 to 3: Original ferro-cement reservoirs showing extensive leaks, cracks and sprawling of reinforcement internally

water services authority and provider, Ilembe District Municipality. Before any transfer could be undertaken, the reservoirs had to be presented in a fully operational and leak-free condition to the Ilembe District Municipality. The results of the investigation done by Umgeni Water included many thoroughly researched options including:

- the use of cementitious repair products
  - the use of bituminous torch-on and paint-on methods of repair
  - the installation of bladder-type liners inside ferro-cement tanks.
- All the above were deemed temporary and unsatisfactory as they provided no lasting warranty/guarantee.

Replacement of the reservoirs was then proposed as an alternative method, including:

Galaxy reservoirs were recommended for a number of reasons, including:

- more than R450 000 cheaper than prefabricated concrete and as much as R930 000 cheaper than pressed steel
- only option to offer a ten-year non-leak guarantee which was welcomed by the Ilembe District Municipality
- the reservoir was constructed on the existing ferro-cement floor/base, requiring minimal site preparation and concrete work
- ease of assembly and construction facilitated that all reservoirs could be replaced
- short contract period and speedy delivery times
- the reservoirs can also be increased in volume or dismantled and reassembled elsewhere.

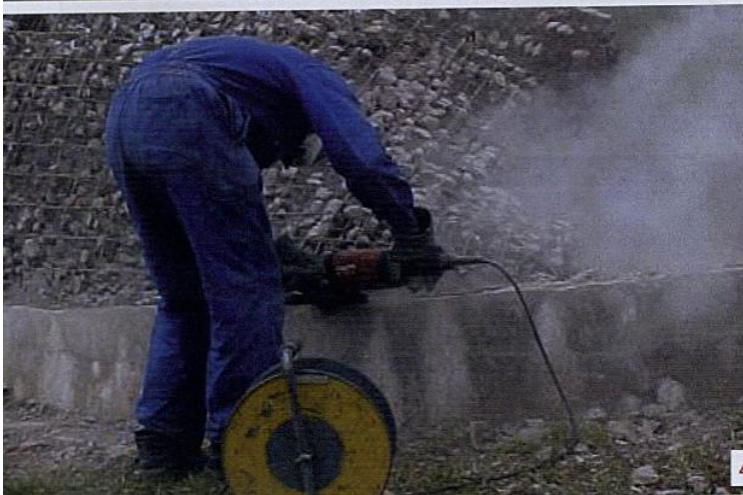
4: Demolishing of reinforced ferro-cement reservoirs, walls demolished to floor level, leaving concrete base only

In a record period of less than three months the ferro-cement reservoirs totalling 17 units, were demolished, the existing floors were levelled where necessary and the new reservoirs were installed and commissioned. **35**

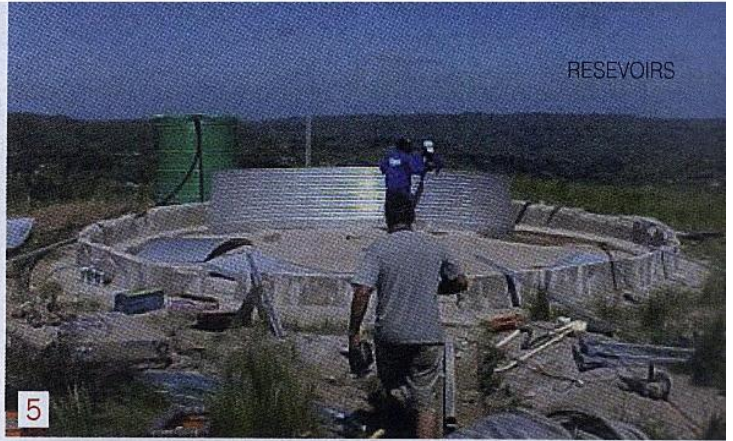
- 5: Installation of the new reservoir inside the 'old reservoir'  
6: Installation of the roof before final trimming  
7: Galaxy break-pressure tank alongside the decommissioned ferro-cement break pressure tank  
8: Operational reservoir used for advertising by Ilembe District Municipality
